# Airstream Tech Help Group

## Furnace Will Not Start (...Sometimes...)

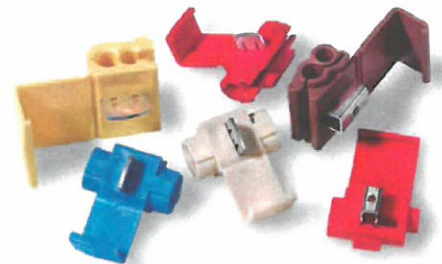
Figure (1) IDC Connectors

These connectors are designed to splice connections into other wires without the need for cutting and soldering. They come in all sorts of sizes and for all types of uses and are used extensively in our RV's. The color of the connector indicates the wire gauge size it is designed for. A quick check is to see if it will move on the wire it is spliced too, which would indicate a poor connection. If it moves at all, do not try to re-clamp the connection, move to an adjacent area on the wire and just replace it with the proper size connector.
